**Flood Control Project Maintenance
Levee Inspections**
LMA District Cover Sheet
Spring 2018 Levee Inspection Results

Reclamation District No. 0003 Grand Island

Spring 2018 Levee Inspection Results

| Waterway | | | Bank | Unit Miles |
|--|---|---|---|---|
| Unit No. 01 Left Bank Steamboat Slough | | | Left | 10.95 |

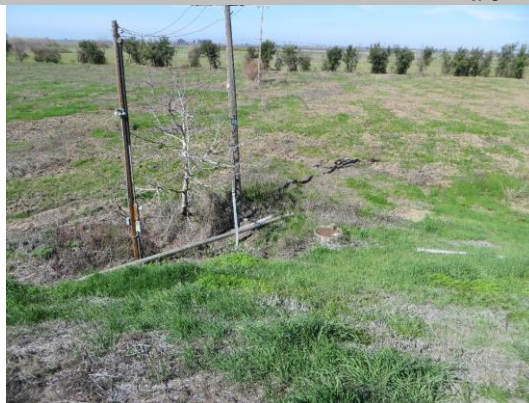
Photo 1 of 3 : UCIP_SP_2018_51426_56825.jpg

FS_ID:51426
DS_ID:22224
EP_NO: N/A
Repair Type: Urgent
Crossing Status: Found
UCIP Comments: 07/06/2016 Same as last inspection. Open pipe on WS may be partially plugged. Unclear whether open pipe beneath pump platform connects to pump and crossing that rest above platform or if they are two separate crossings. If they are connected, positive closure device on pump may prevent backflow. Appears abandoned. (DWR UCIP - K. Fazel)02/24/2014 Pipe open on WS toe-visible under pump at WS toe. Pipe abandoned and should be done so properly. (DWR UCIP - G. Wylie)
FIELD_STRUCT_DESC: *ABANDONED* 6-inch steel irrigation discharge pipe through the levee, 5.4 feet below the crown. Pipe visible beneath a pump platform on the waterside (WS). Another larger steel pipe (DSID 22223) visible through the WS slope and connected to a centrifugal pump with a closure valve resting over a platform on the WS. 2-inch electrical conduit through the levee at the same location leads to service pole on the landside (LS). [Additional Reference(s): DWR Levee Log, 1993. USACE Sacramento O&M Manual 104, February 1960 (RM 19.39)]. Levee Log mentions the 6-inch pipe is plugged and cut off.

Approximate location of pipe on LS toe.

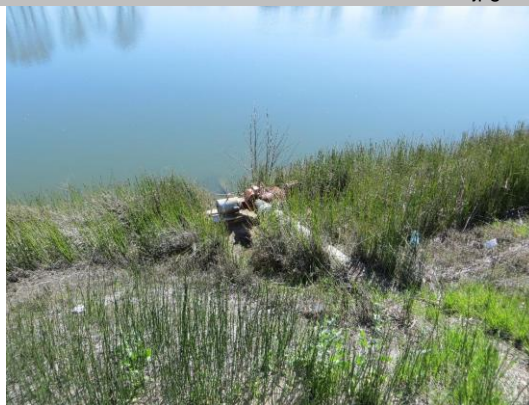
Photo 2 of 3 : UCIP_SP_2018_51426_56824.jpg

Pipe visible under pump on WS slope.

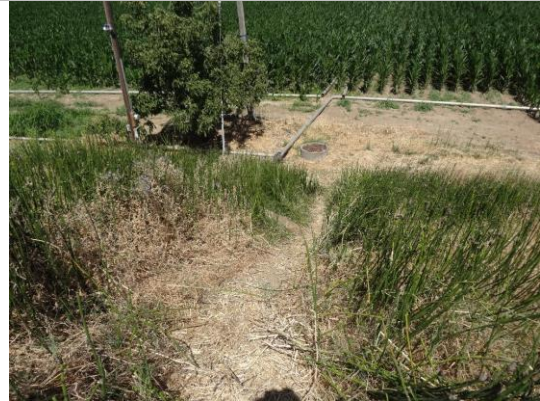
Photo 3 of 3 : UCIP_SP_2018_51426_75547.jpg

LS view; standpipe and power pole off LS toe.

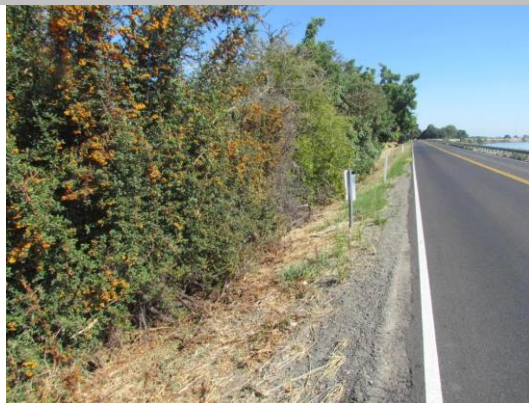
Photo 1 of 1 : SP_2018_RD0003_25_13_20180305_00020.jpg

| Dense landscaping and vegetation on landside slope and toe. | | | | | |

Looking north at dense vegetation on landward slope.

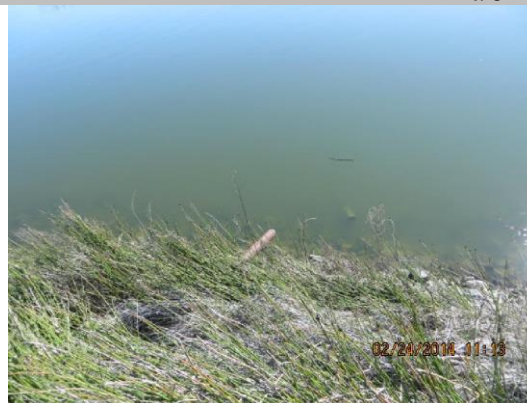
Photo 1 of 2 : UCIP_SP_2018_30903_56801.jpg

| FS_ID:30903 DS_ID:22227 EP_NO: N/A Repair Type: Non-Urgent Crossing Status: Found UCIP Comments: Need to verify type of abandonment. Does not appear to have been abandoned properly. FIELD_STRUCT_DESC: *ABANDONED* 5-inch steel gravity irrigation pipe through the levee, invert elevation 3.4 feet below the crown. (J. del Costello). [Additional Reference(s): DWR Levee Log, 1993. USACE Sacramento O&M Manual 104, February 1960, (RM 19.63)]. FS Date: 2/24/2014 | | | | | |

Pipe visible at WS toe.

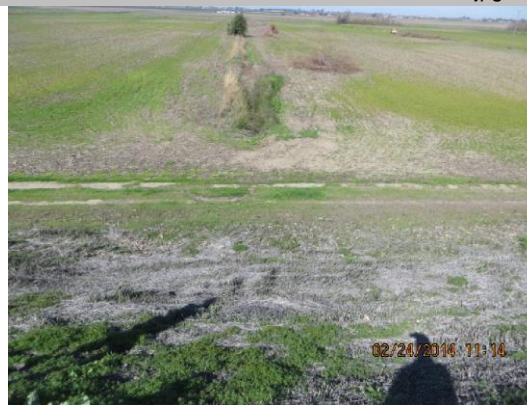
Photo 2 of 2 : UCIP_SP_2018_30903_56800.jpg

Swale off LS toe likely along same alignment as pipe.

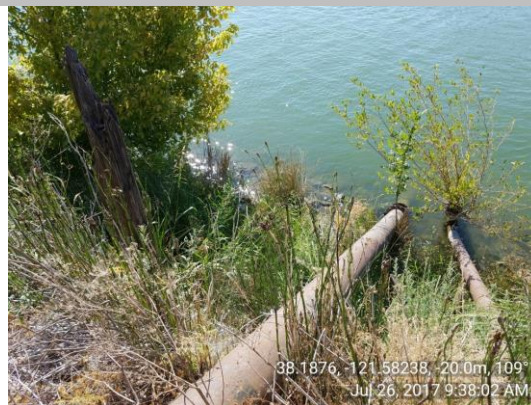
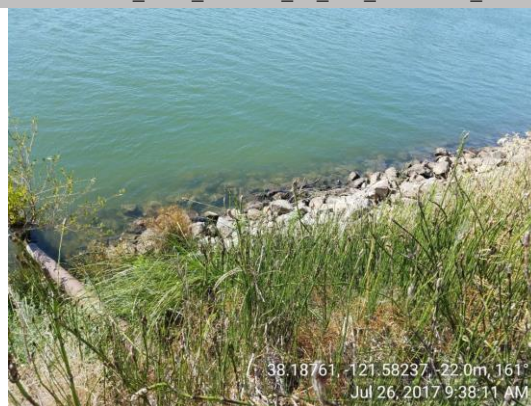
| Item | 2017 Storm Damage | | | 38.187528 ° | 38.187781 ° |
| Repair Type: Erosion | | | | | |

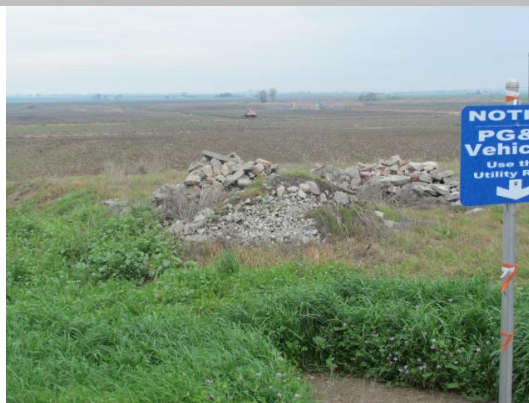
Photo 1 of 2 : SP_2018_RD0003_25_76_20180305_00060.jpg

| Concrete rubble on landside slope. | | | | | |

Looking northwest at concrete rubble on landward slope.

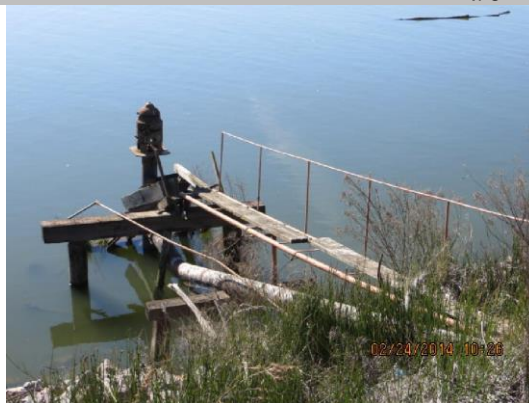
Photo 1 of 3 : UCIP_SP_2018_41643_56793.jpg

FS_ID:41643
DS_ID:22231
EP_NO: 1311
Repair Type: Non-Urgent
Crossing Status: Found
UCIP Comments: Appears abandoned and if so should be done so properly. Walkway and pier falling apart.
FIELD_STRUCT_DESC: 12-inch steel irrigation discharge pipe through the levee, invert elevation 7.8 feet below the crown. Pump on a pile structure in the river. 42-inch concrete standpipe and a meter pole at the landside (LS) toe. The 12-inch pipe appears to be sleeved with a 10-inch pipe, as it measures 10 inches on both slopes. 1.5-inch electrical conduit through the levee at the same location. (Plans for installing three pipes through the levee authorized under Permit No. 1311, 1948 - Joe Lopes). [Additional Reference(s): DWR Levee Log, 1993. USACE Sacramento O&M Manual 104, February 1960, (RM 20.37)].
FS Date: 2/24/2014

Pump on structurally failing pier/walkway on WS toe.

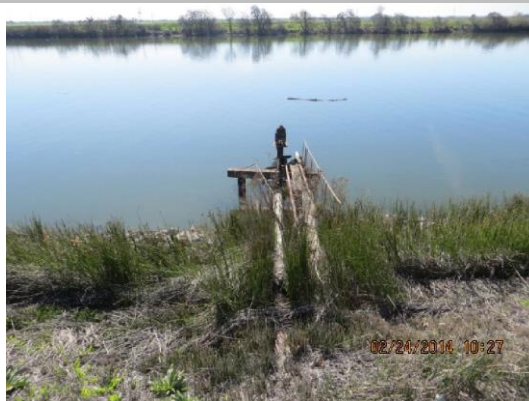
Photo 2 of 3 : UCIP_SP_2018_41643_56792.jpg

Pump on pier at WS toe.

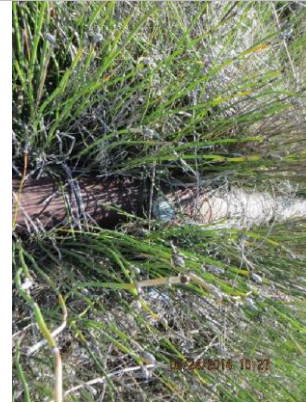
Photo 3 of 3 : UCIP_SP_2018_41643_56791.jpg

Siphon breaker on WS shoulder.

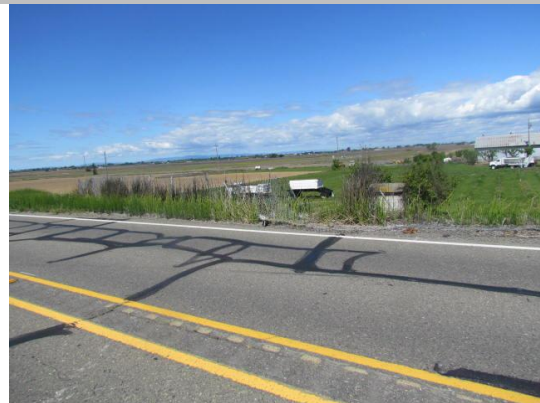
Photo 1 of 1 : SP_2018_RD0003_25_21_20180305_00028.jpg

| Fence on landside shoulder. | | | | | |

Looking west at cyclone fence on landward shoulder.

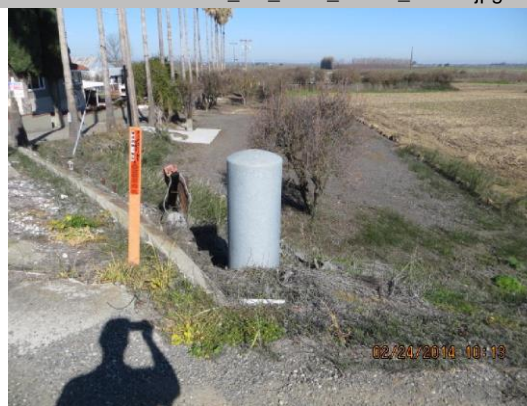
Photo 1 of 3 : UCIP_SP_2018_40542_56797.jpg

| FS_ID:40542 DS_ID:22233 EP_NO: 1311 Repair Type: Non-Urgent Crossing Status: Found UCIP Comments: Systed appears abandoned and if so, should be done so properly. FIELD_STRUCT_DESC: 2-inch galvanized iron domestic water line through the levee, 4 feet below the crown. Hand pump and pump on the waterside (WS) slope. Tank on the landside (LS) shoulder. (Plans for installing three pipes through the levee authorized under Permit No. 1311, 1948 - Joe Lopes). [Additional Reference(s): DWR Levee Log, 1993]. FS Date: 2/24/2014 | | | | | |

Tank on LS shoulder.

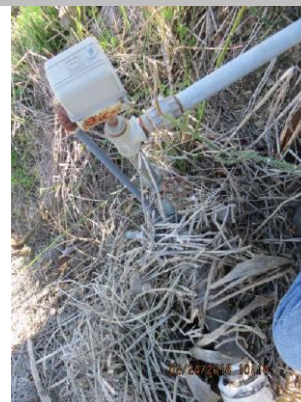
Photo 2 of 3 : UCIP_SP_2018_40542_56796.jpg

Valve next to tank on LS shoulder.

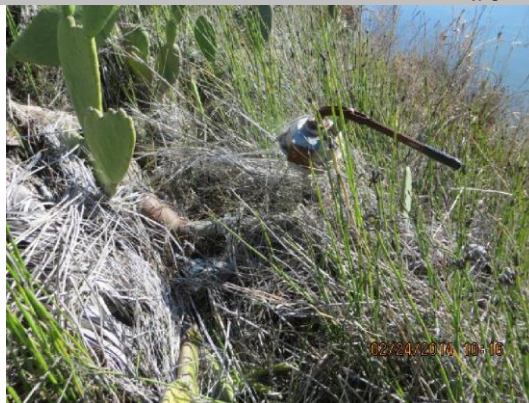
Photo 3 of 3 : UCIP_SP_2018_40542_56795.jpg

Hand pump and electric pump on WS slope.

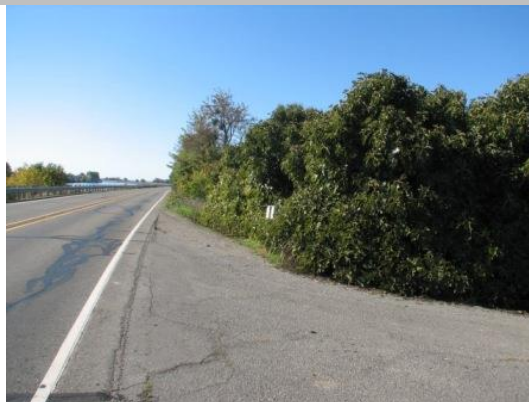
Photo 1 of 2 : SP_2018_RD0003_25_11_20180305_00015.jpg

Landscaping on levee slope and toe obstructs access and visibility.

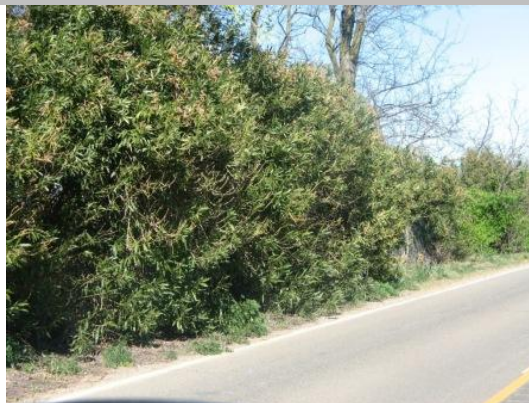
Photo 2 of 2 : SP_2018_RD0003_25_11_20180305_00016.jpg

Oleander on landside shoulder blocking view of levee slope from LM 5.81 to 5.86

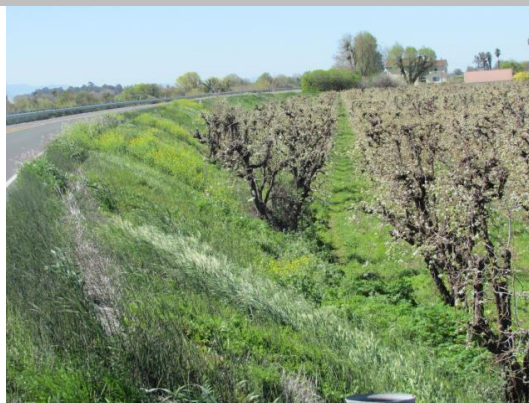
Photo 1 of 1 : SP_2018_RD0003_25_54_20180305_00044.jpg

| Orchard on lower levee slope | | | | | |

Looking south at trees on landward toe.

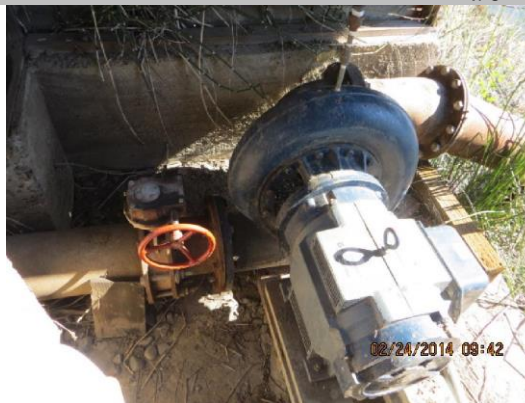
Photo 1 of 3 : UCIP_SP_2018_30864_56747.jpg

| FS_ID:30864 DS_ID:22238 EP_NO: 9430 Repair Type: Non-Urgent Crossing Status: Found UCIP Comments: Annular space not grouted. FIELD_STRUCT_DESC: 12-inch steel irrigation discharge pipe through the levee, invert elevation 4 feet below the crown. 8-inch pipe sleeved through the 12-inch pipe. Pump and gate valve in a pump house and a vent on the waterside (WS) slope. Siphon breaker in a 16-inch corrugated metal pipe (CMP) riser on the landside (LS) shoulder. 4-foot concrete standpipe, power pole, and meter on the LS toe. (Retention of an irrigation pumping plant with a centrifugal pump and accessories in a corrugated metal shed on the WS slope above rock authorized under Automatic Board Order (ABO) issued as Permit No. 9430, 1974 - M. B. Millhauser). [Additional Reference(s): DWR Levee Log, 1993. USACE Sacramento O&M Manual 104, February 1960, (RM 20.99)]. FS Date: 2/24/2014 | | | | | |

Pump and gate valve inside pumphouse on WS slope.

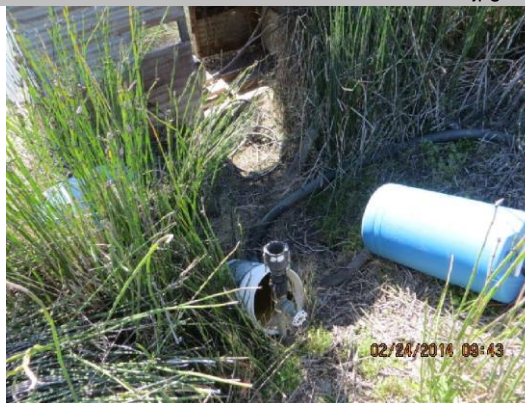
Photo 2 of 3 : UCIP_SP_2018_30864_56746.jpg

Vent next to pumphouse on WS slope.

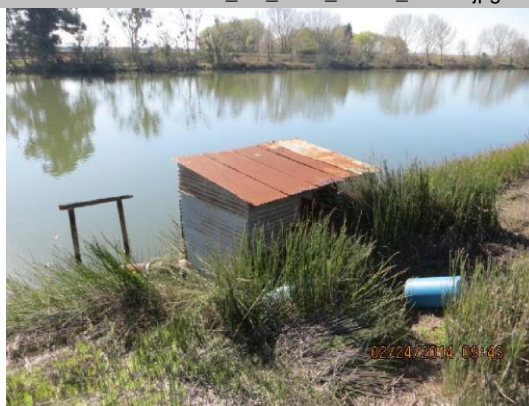
Photo 3 of 3 : UCIP_SP_2018_30864_56745.jpg

Pumphouse on WS slope.

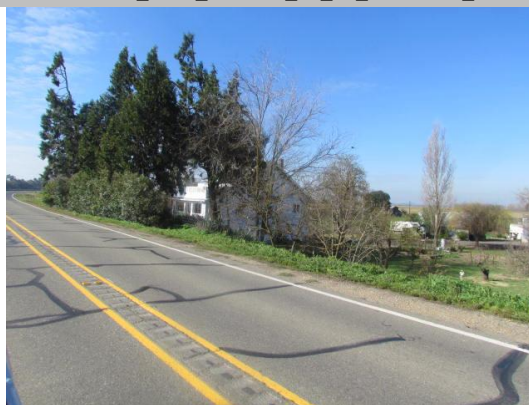
Photo 1 of 1 : SP_2018_RD0003_25_88_20180305_00077.jpg

Looking south at landscaping on landside shoulder.

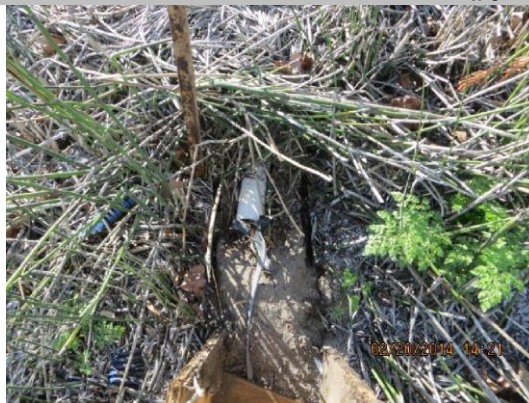
Photo 1 of 2 : UCIP_SP_2018_31291_57310.jpg

| FS_ID:31291 DS_ID:24841 EP_NO: N/A Repair Type: Non-Urgent Crossing Status: Found UCIP Comments: No permit identified for this crossing. FIELD_STRUCT_DESC: 2.5-inch polyvinyl chloride (PVC) conduit, 4 feet below the crown. 0.5-inch water line and electrical line sleeved through the conduit. Conduit provides service to a boat dock. This crossing was field discovered. FS Date: 2/20/2014 | | | | | | |

Pipe visible on WS slope.

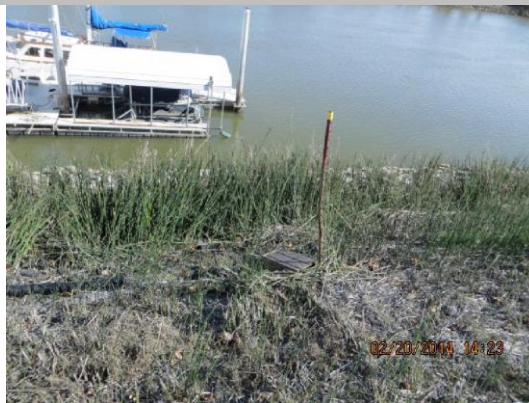
Photo 2 of 2 : UCIP_SP_2018_31291_57309.jpg

Pipe visible on WS slope.

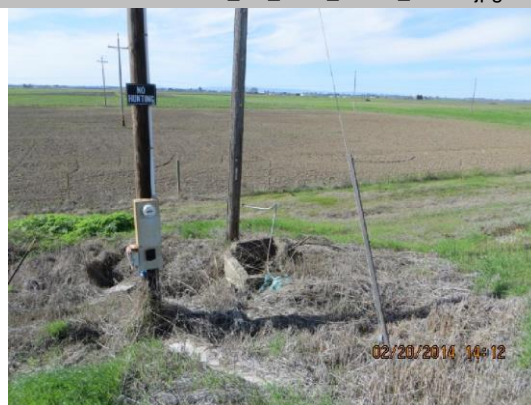
Photo 1 of 3 : UCIP_SP_2018_30672_56446.jpg

| FS_ID:30672 DS_ID:22242 EP_NO: N/A Repair Type: Non-Urgent Crossing Status: Found UCIP Comments: Appears abandoned and if so should be done so properly. FIELD_STRUCT_DESC: *ABANDONED* 7-inch steel irrigation discharge pipe through the levee, invert elevation 7.6 feet below the crown. Pump in a pump house on a concrete pad on the waterside (WS) slope. Gate valve on the WS slope. 44-inch by 44-inch concrete distribution box, joint pole (JP), and meter at the landside (LS) toe. [Additional Reference(s): DWR Levee Log, 1993. USACE Sacramento O&M Manual 104, February 1960, (RM 21.58)]. FS Date: 2/20/2014 | | | | | | |

Concrete distribution box, power pole, and meter on LS toe.

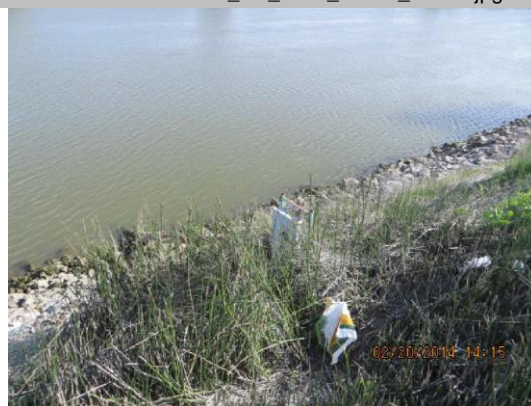
Photo 2 of 3 : UCIP_SP_2018_30672_56445.jpg

Pump in vegetation on WS slope.

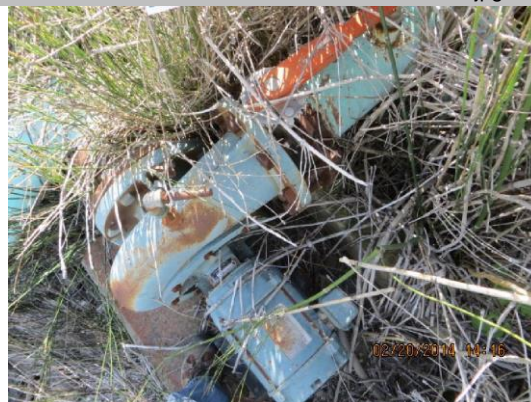
Photo 3 of 3 : UCIP_SP_2018_30672_56444.jpg

Pump on pad with butterfly valve on WS slope.

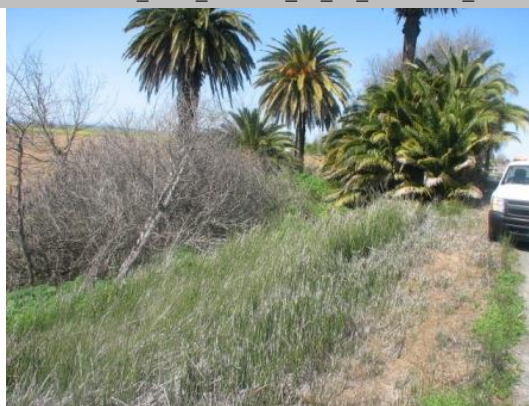
Photo 1 of 3 : SP_2018_RD0003_25_12_20180305_00017.jpg

Dense trees at landside toe and shoulder.

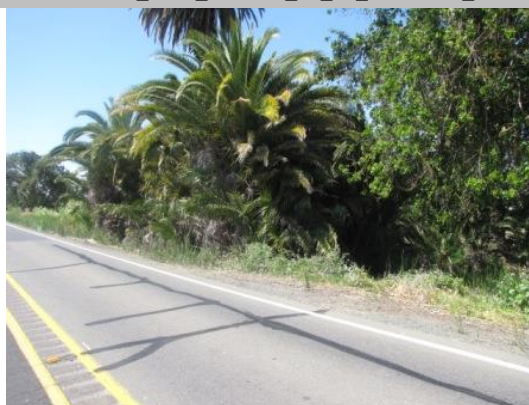
Photo 2 of 3 : SP_2018_RD0003_25_12_20180305_00018.jpg

Looking southwest at updated dense veg. on landside slope.

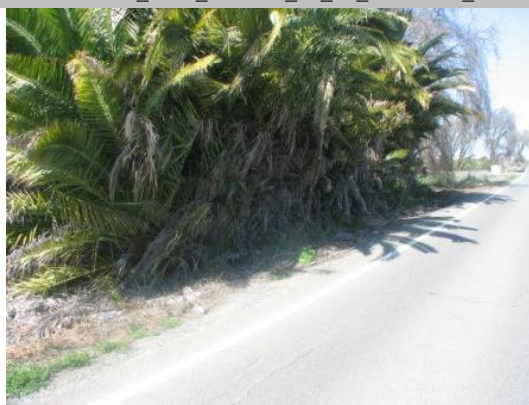
Photo 3 of 3 : SP_2018_RD0003_25_12_20180305_00019.jpg

Front view of palm trees on landside shoulder.

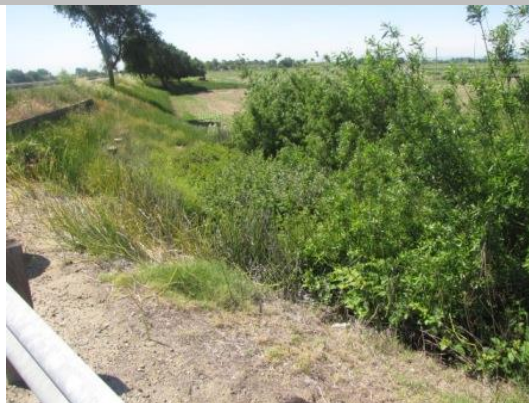
Photo 1 of 1 : SP_2018_RD0003_25_16_20180305_00025.jpg

| Dense vegetation at landside toe. | | | | | |

Looking southwest at dense veg. on landside toe.

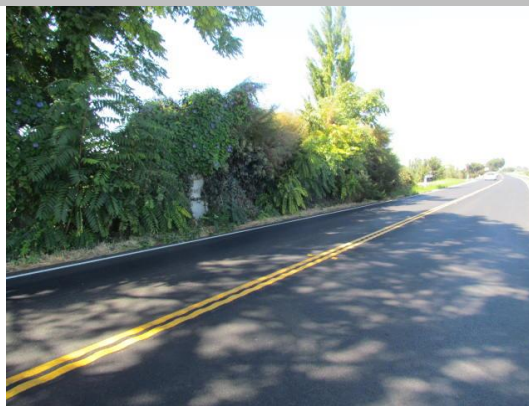
Photo 1 of 1 : SP_2018_RD0003_25_55_20180305_00045.jpg

Looking northwest at dense landscaping on landward shoulder and slope.

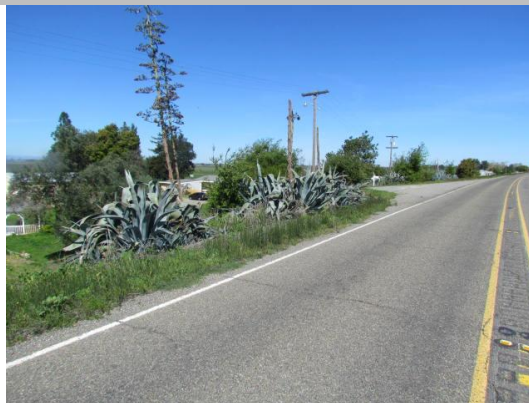
Photo 1 of 2 : SP_2018_RD0003_25_56_20180305_00046.jpg

Looking northwest at century plants on landside shoulder and slope.

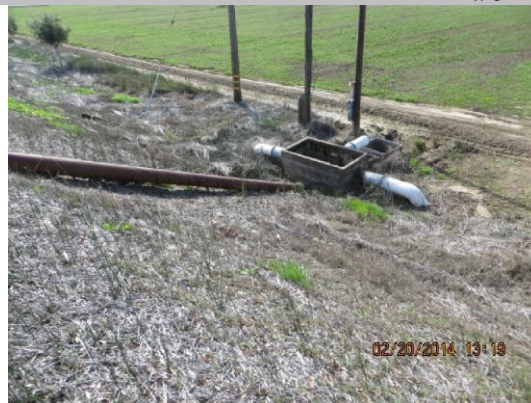
Photo 1 of 3 : UCIP_SP_2018_30648_56414.jpg

Pipe visible on LS slope with concrete distribution box on LS toe.

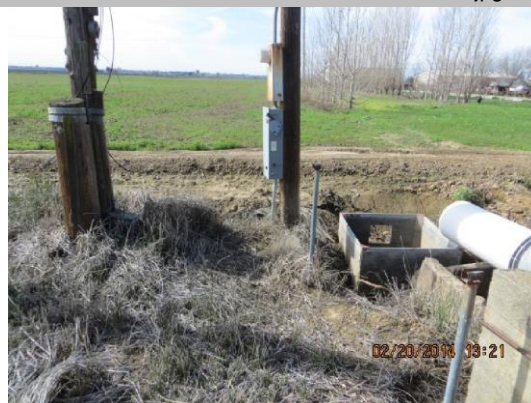
Photo 2 of 3 : UCIP_SP_2018_30648_56413.jpg

Meter on pole next to concrete distribution box on LS toe.

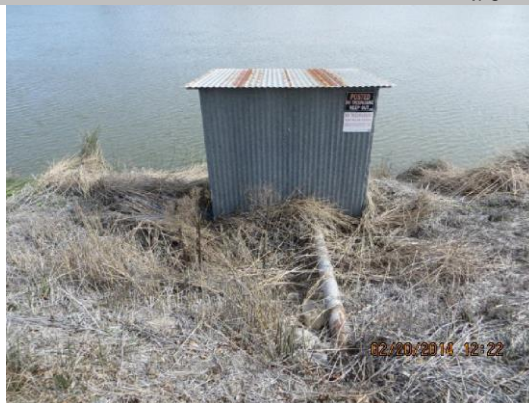
Photo 1 of 3 : UCIP_SP_2018_30643_56402.jpg

Pumphouse on WS slope.

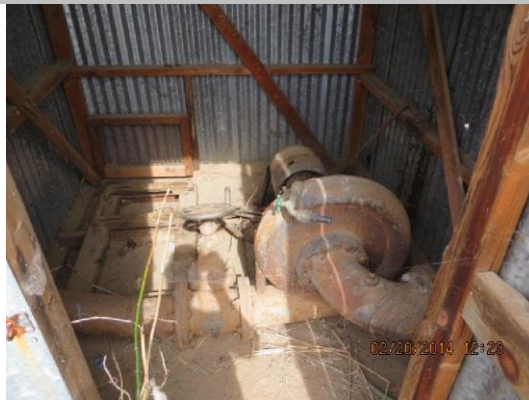
Photo 2 of 3 : UCIP_SP_2018_30643_56401.jpg

Pump, gate valve and pipe visible in pumphouse on WS slope.

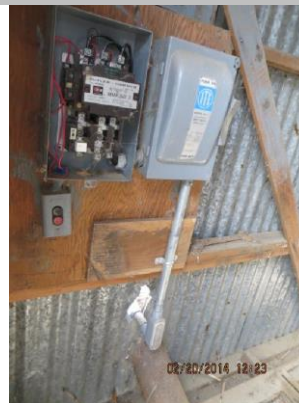
Photo 3 of 3 : UCIP_SP_2018_30643_56400.jpg

| FS_ID:30643 DS_ID:22249 EP_NO: N/A Repair Type: Non-Urgent Crossing Status: Found UCIP Comments: Appears abandoned and if so should be done so properly. FIELD_STRUCT_DESC: 6-inch steel irrigation discharge pipe through the levee, invert elevation 3.5 feet below the crown. Pump and gate valve in a pump house on the waterside (WS) slope. 36-inch concrete standpipe on the landside (LS). 1.5-inch electrical conduit through the levee at the same location. Power pole and meter on the LS slope. (L. Souza). [Additional Reference(s): DWR Levee Log, 1993. USACE Sacramento O&M Manual 104, February 1960, (RM 22.60)]. FS Date: 2/20/2014 | | | | | | |

Electrical panel inside pumphouse on WS slope.

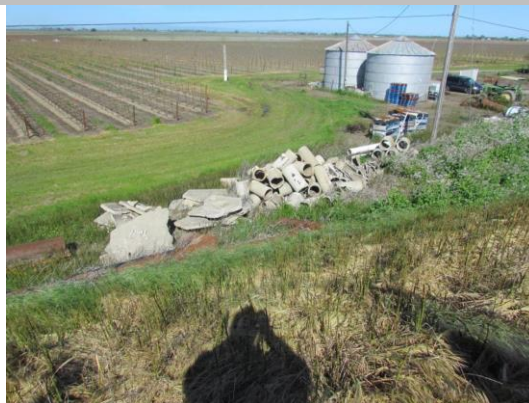
Photo 1 of 1 : SP_2018_RD0003_25_159_20180305_00138.jpg

| Old concrete pipes stored at landside toe. | | | | | |

Looking west at concrete rubble stockpile at landward toe.

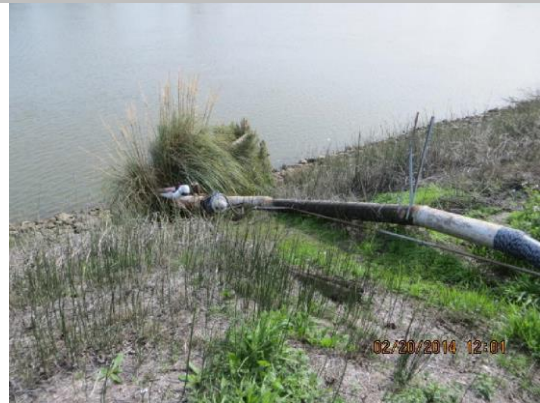
Photo 1 of 2 : UCIP_SP_2018_30623_56381.jpg

| FS_ID:30623 DS_ID:22251 EP_NO: 886 Repair Type: Non-Urgent Crossing Status: Found UCIP Comments: Erosion under pipe on LS slope. FIELD_STRUCT_DESC: 10-inch steel irrigation discharge pipe through the levee, invert elevation 3.8 feet below the crown. Slant pump on the waterside (WS) slope. 36-inch concrete standpipe at the landside (LS) toe with a filter plant. Service pole on the LS slope. 1.5-inch steel electrical conduit through the levee at the same location. (Plans for the installation and maintenance of an irrigation pumping plant, including an 8-inch discharge pipe through the levee authorized under Permit No. 886, 1942 - Georgia McKuen. Retention of an irrigation pumping plant with a slant pump and a 10-inch steel pipe through the levee above the floodplain and a service pole near the LS shoulder authorized under Automatic Board Order (ABO) issued as Permit No. 9437, 1974 - Joseph Green Jr. [Additional Reference(s): DWR Levee Log, 1993, 12-inch pipe referenced. USACE Sacramento O&M Manual, February 1960, (RM 22.96)]. FS Date: 2/20/2014 | | | | | |

Pipe and slant pump on WS slope.

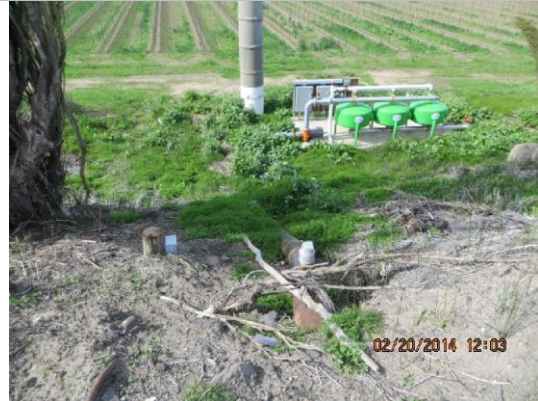
Photo 2 of 2 : UCIP_SP_2018_30623_56380.jpg

| FS_ID:30623 DS_ID:22251 EP_NO: 886 Repair Type: Non-Urgent Crossing Status: Found UCIP Comments: Erosion under pipe on LS slope. FIELD_STRUCT_DESC: 10-inch steel irrigation discharge pipe through the levee, invert elevation 3.8 feet below the crown. Slant pump on the waterside (WS) slope. 36-inch concrete standpipe at the landside (LS) toe with a filter plant. Service pole on the LS slope. 1.5-inch steel electrical conduit through the levee at the same location. (Plans for the installation and maintenance of an irrigation pumping plant, including an 8-inch discharge pipe through the levee authorized under Permit No. 886, 1942 - Georgia McKuen. Retention of an irrigation pumping plant with a slant pump and a 10-inch steel pipe through the levee above the floodplain and a service pole near the LS shoulder authorized under Automatic Board Order (ABO) issued as Permit No. 9437, 1974 - Joseph Green Jr. [Additional Reference(s): DWR Levee Log, 1993, 12-inch pipe referenced. USACE Sacramento O&M Manual, February 1960, (RM 22.96)]. FS Date: 2/20/2014 | | | | | | |

vent, pipe, standpipe, and filter plant on LS.

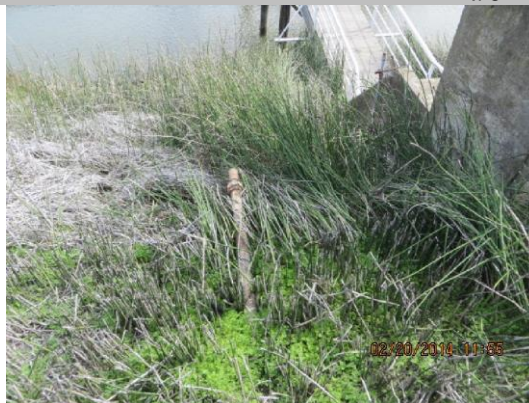
Photo 1 of 1 : UCIP_SP_2018_30588_56377.jpg

| FS_ID:30588 DS_ID:22254 EP_NO: 9436 Repair Type: Non-Urgent Crossing Status: Found UCIP Comments: Pipe appears abandoned and if so should be done so properly. FIELD_STRUCT_DESC: 2-inch steel water line through the levee, 6.5 feet below the crown. (Retention of a 2-inch steel pipe water line through the levee above the floodplain authorized under Automatic Board Order (ABO) issued as Permit No. 9436, 1974 - Harry A. Sergeant. Plans to construct a floating dock with a walkway on the levee and revive use of an existing reinforced concrete tunnel through the levee authorized under Permit No. 8612, 1974 - Harry A. and Jennie E. Sergeant). [Additional Reference(s): DWR Levee Log, 1993]. FS Date: 2/20/2014 | | | | | |

Pipe visible next to concrete culvert on WS slope.

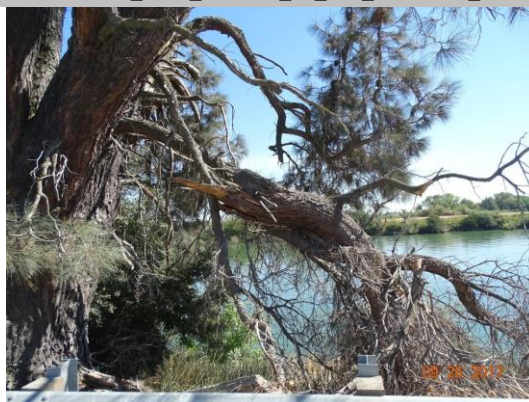
Photo 1 of 1 : SP_2018_RD0003_25_162_20180305_00139.jpg

Looking east at the waterside slope.

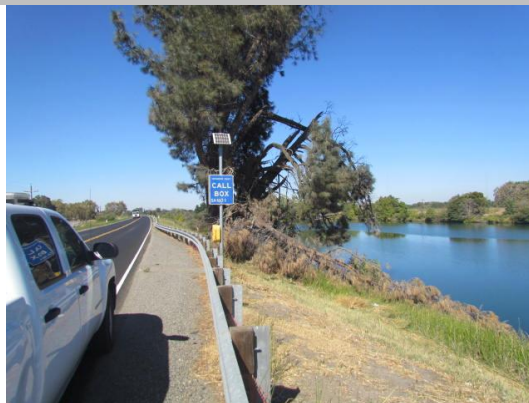
Photo 1 of 2 : SP_2018_RD0003_25_15_20180305_00023.jpg

| Broken tree branches on waterside shoulder and slope. | | | | | | |

Looking northeast at broken and cracked tree branches on waterward slope.

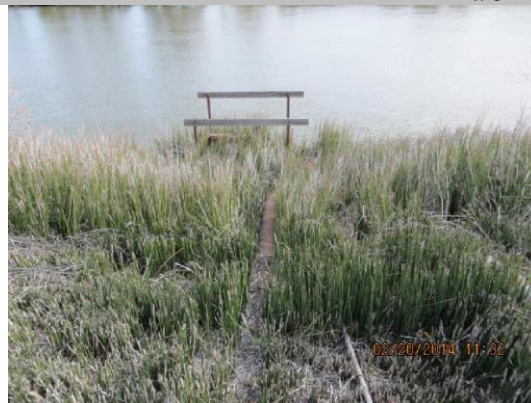
Photo 1 of 3 : UCIP_SP_2018_50186_56371.jpg

FS_ID:50186
DS_ID:22256
EP_NO: N/A
Repair Type: Urgent
Crossing Status: Found
UCIP Comments: 07/06/2016 Pipe is open on WS slope. Same as last inspection. (DWR UCIP - K. Fazel)02/20/2014 Appears abandoned and if so should be done properly. Large erosion holes in 2 places on LS toe due to irrigation flows. (DWR FPIIB - G. Wylie)
FIELD_STRUCT_DESC: *ABANDONED* 12-inch steel irrigation discharge pipe through the levee, invert elevation 4.8 feet below the crown. Pump on the waterside (WS) slope. 1.5-inch steel electrical conduit through the levee at the same location. 5-foot by 5-foot concrete distribution box at the landside (LS) toe. [Additional Reference(s): DWR Levee Log, 1993, 10-inch pipe referenced. USACE Sacramento O&M Manual 104, February 1960, (RM 23.20), 10-inch pipe referenced]. Levee Log incorrectly references Gemignani as the owner of this pipe.
FS Date: 7/6/2016

Pipe and slant pump visible on WS slope.

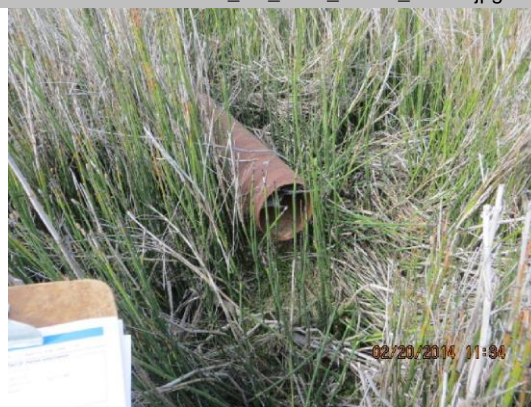
Photo 2 of 3 : UCIP_SP_2018_50186_56370.jpg

Open pipe visible on WS slope.

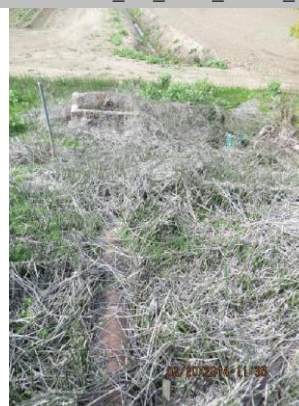
Photo 3 of 3 : UCIP_SP_2018_50186_56374.jpg

| FS_ID:50186 DS_ID:22256 EP_NO: N/A Repair Type: Urgent Crossing Status: Found UCIP Comments: 07/06/2016 Pipe is open on WS slope. Same as last inspection. (DWR UCIP - K. Fazel)02/20/2014 Appears abandoned and if so should be done properly. Large erosion holes in 2 places on LS toe due to irrigation flows. (DWR FPIIB - G. Wylie) FIELD_STRUCT_DESC: *ABANDONED* 12-inch steel irrigation discharge pipe through the levee, invert elevation 4.8 feet below the crown. Pump on the waterside (WS) slope. 1.5-inch steel electrical conduit through the levee at the same location. 5-foot by 5-foot concrete distribution box at the landside (LS) toe. [Additional Reference(s): DWR Levee Log, 1993, 10-inch pipe referenced. USACE Sacramento O&M Manual 104, February 1960, (RM 23.20), 10-inch pipe referenced]. Levee Log incorrectly references Gemignani as the owner of this pipe. FS Date: 7/6/2016 | | | | | | |

Pipe and concrete distribution box visible on LS slope.

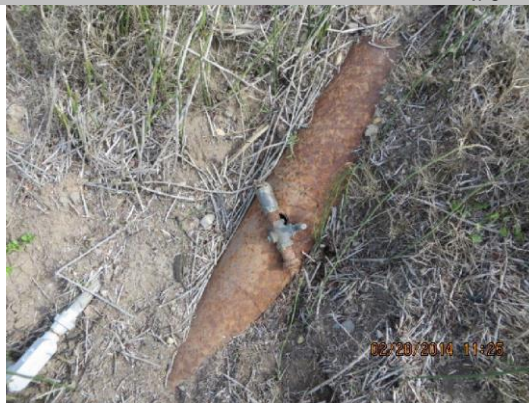
Photo 1 of 3 : UCIP_SP_2018_30577_56345.jpg

| UCIP Comments: Siphon breaker broken off pipe on LS slope. | | | | | |

Siphon breaker/vent broken off pipe at LS slope.

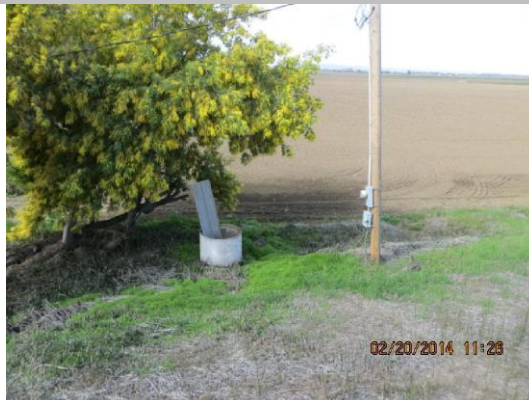
Photo 2 of 3 : UCIP_SP_2018_30577_56344.jpg

Concrete standpipe, powerpole, and meter visible on LS toe.

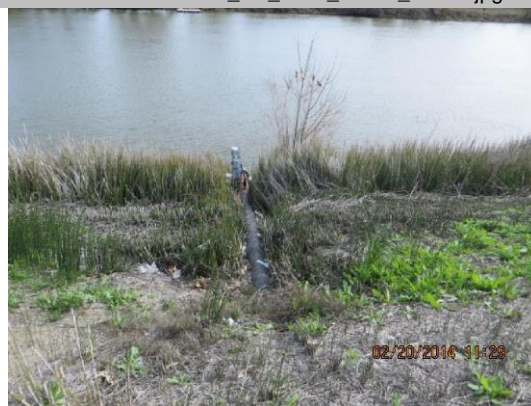
Photo 3 of 3 : UCIP_SP_2018_30577_56346.jpg

| UCIP Comments: Siphon breaker broken off pipe on LS slope. | | | | | | |

Pump and pipe visible on WS slope.

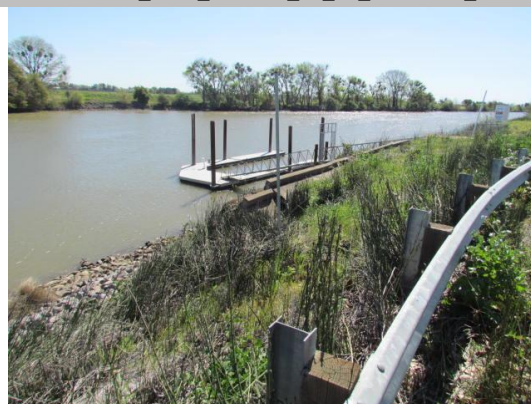
Photo 1 of 1 : SP_2018_RD0003_25_59_20180305_00048.jpg

| Concrete footings and retaining walls at levee toe and slopes. Has been in place for several years. | | | | | |

Looking southeast at concrete structure on waterward slope.

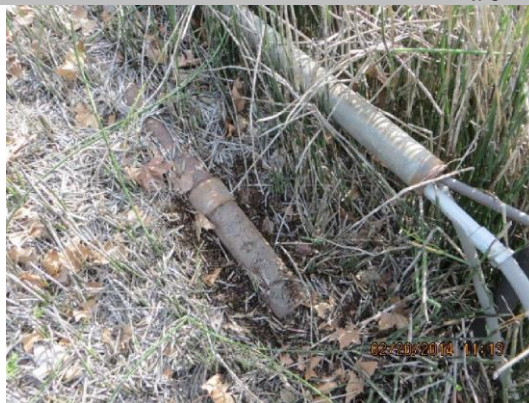
Photo 1 of 1 : UCIP_SP_2018_30568_56321.jpg

| FS_ID:30568 DS_ID:22259 EP_NO: N/A Repair Type: Non-Urgent Crossing Status: Found UCIP Comments: Pipe abandoned and should be done so properly. Rusted through and open on LS slope. Possibly just a section of discarded pipe. FIELD_STRUCT_DESC: *ABANDONED* 5-inch steel pipe of an unknown purpose through the levee, 5 feet below the crown. Open on the landside (LS) end. [Additional Reference(s): DWR Levee Log, 1993]. FS Date: 2/20/2014 | | | | | |

Steel pipe visible on LS Slope.

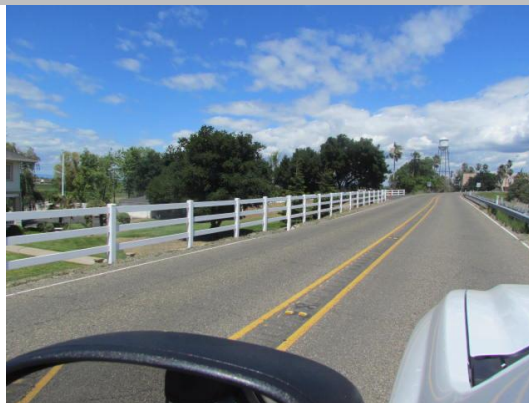
Photo 1 of 1 : SP_2018_RD0003_25_78_20180305_00065.jpg

| Unauthorized fence. | | | | | |

Looking northwest at unauthorized fence on landward shoulder.

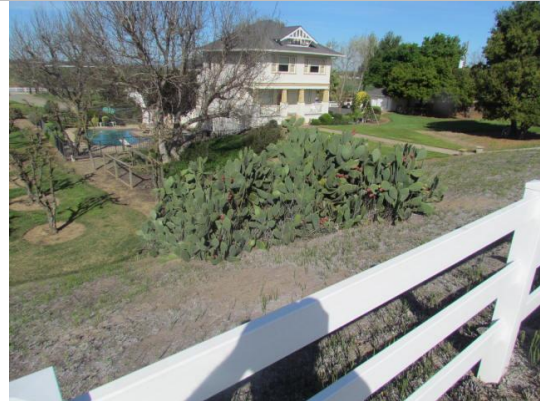
Photo 1 of 1 : SP_2018_RD0003_25_158_20180305_00137.jpg

| Large cluster of cactus on landside slope. | | | | | |

Looking west at cactus on landward slope and toe.

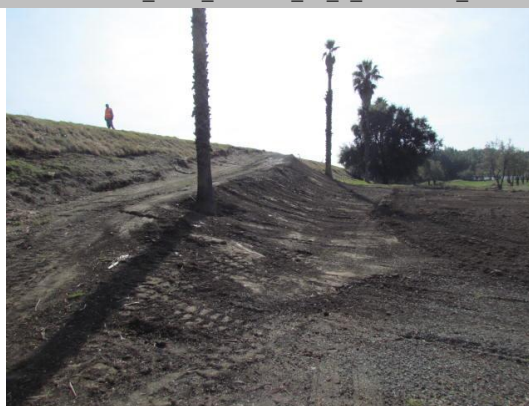
Photo 1 of 3 : SP_2018_RD0003_25_2_20180305_00003.jpg

| New landowner installed unauthorized ramp on landside slope. District engineer has spoken with landowner about removing the ramp. Wild grape vines growing on ramp slope. | | | | | |

Looking south at unauthorized ramp on landside slope.

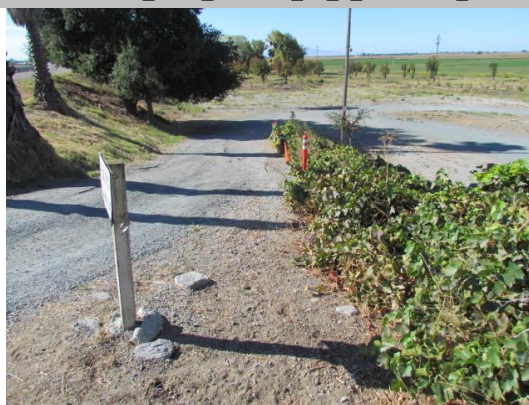
Photo 2 of 3 : SP_2018_RD0003_25_2_20180305_00004.jpg

Looking southwest at unauthorized ramp on landside. 2013

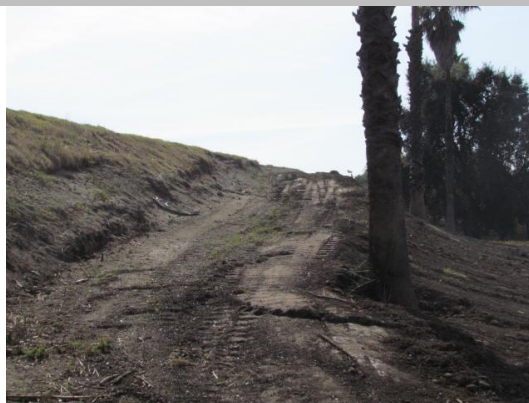
Photo 3 of 3 : SP_2018_RD0003_25_2_20180305_00005.jpg

Looking south at ramp on landside slope.

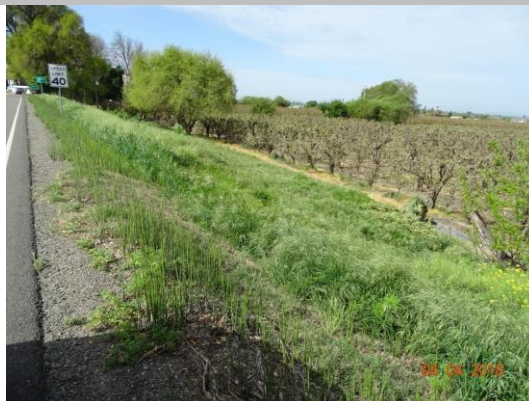
Photo 1 of 1 : SP_2018_RD0003_25_184_20180404_00294.jpg

Heavy vegetation on landside slope prevents inspection.

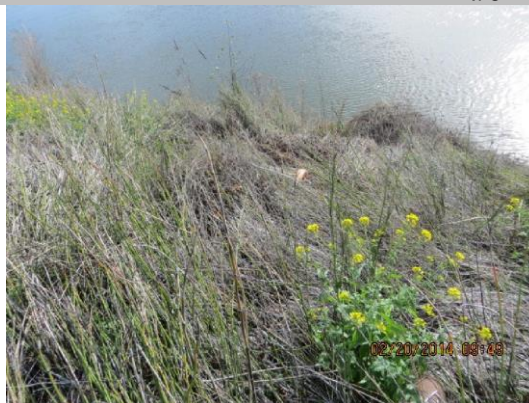
Photo 1 of 3 : UCIP_SP_2018_30507_56120.jpg

| FS_ID:30507 DS_ID:22271 EP_NO: 3295 Repair Type: Non-Urgent Crossing Status: Found UCIP Comments: Possibly Abandoned and if so should be done properly. Pipe shows sigs of decay on LS toe and there is pipe debris on the WS slope. Good candidate for video inspection. FIELD_STRUCT_DESC: 10-inch steel irrigation discharge pipe through the levee, 6.5 feet below the crown. Pump on the waterside (WS) slope with a gate valve. Gate valve, power pole, and meter visible on the landside (LS) toe. 1.5-inch steel electrical conduit through the levee at the same location. (Plans for installation of a pump and motor on the WS slope of the levee and installation of an 8-inch pipe through an existing 12-inch pipe through the levee authorized under Permit No. 3295, 1960 - Robert and Craig James). [Additional Reference(s): DWR Levee Log, 1993]. FS Date: 2/20/2014 | | | | | |

Pipe and pump covered by vegetation on WS slope.

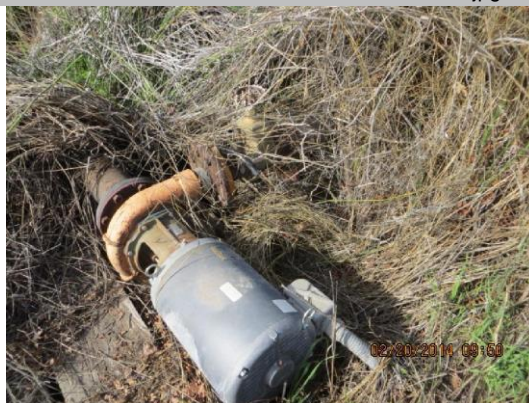
Photo 2 of 3 : UCIP_SP_2018_30507_56119.jpg

Pump and gate valve on WS slope.

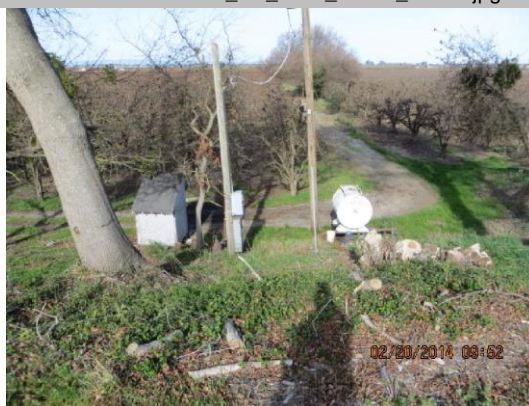
Photo 3 of 3 : UCIP_SP_2018_30507_56118.jpg

| FS_ID:30507 DS_ID:22271 EP_NO: 3295 Repair Type: Non-Urgent Crossing Status: Found UCIP Comments: Possibly Abandoned and if so should be done properly. Pipe shows sigs of decay on LS toe and there is pipe debris on the WS slope. Good candidate for video inspection. FIELD_STRUCT_DESC: 10-inch steel irrigation discharge pipe through the levee, 6.5 feet below the crown. Pump on the waterside (WS) slope with a gate valve. Gate valve, power pole, and meter visible on the landside (LS) toe. 1.5-inch steel electrical conduit through the levee at the same location. (Plans for installation of a pump and motor on the WS slope of the levee and installation of an 8-inch pipe through an existing 12-inch pipe through the levee authorized under Permit No. 3295, 1960 - Robert and Craig James). [Additional Reference(s): DWR Levee Log, 1993]. FS Date: 2/20/2014 | | | | | | |

Pipe to left of power pole and meter at LS toe.

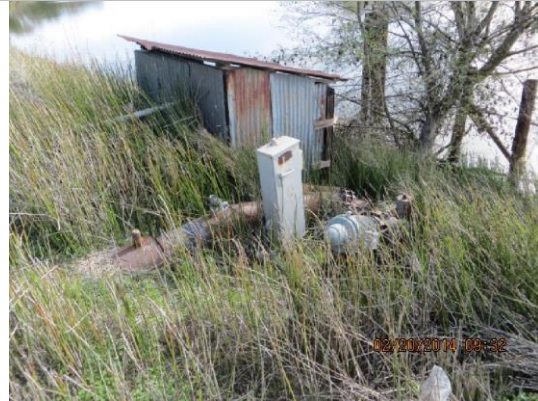
Photo 1 of 3 : UCIP_SP_2018_50187_57439.jpg

FS_ID:50187
DS_ID:22272
EP_NO: N/A
Repair Type: Urgent
Crossing Status: Found
UCIP Comments: 07/06/2016 Highway has been since paved so pot hole not visible. No evidence of repair. (DWR UCIP - kfazel)02/20/2014 Dip in pavement over pipe on North bound lane may indicate internal leak in pipe. Good candidate for video inspection. (DWR UCIP - pamatya)
FIELD_STRUCT_DESC: 16-inch steel irrigation discharge pipe through the levee, invert elevation 6.2 feet below the crown. 12-inch steel pipe sleeved through the existing 16-inch pipe with the annular space grouted. Slant pump on the waterside (WS) slope next to the pump house. Butterfly valve and siphon breaker/vent at the pump on the WS slope. Siphon breaker/vent on the landside (LS) shoulder. Filter, pump, vent, and butterfly valve at the LS toe. The current 16-inch pipe replaced the abandoned 10-inch pipe under DSID 22273. (Plans for plugging up an existing 10-inch steel discharge pipe and installing a new 16-inch steel discharge pipe through the levee authorized under Permit No. 1136, 1946 - Dennis W. Leary. Plans to install a 12-inch irrigation intake pipe inside an existing 16-inch pipe in the levee authorized under Permit No. 14811, 1988 - Leary Ranch, Inc).

Pump, pipe, butterfly valve, and shed visible on WS slope.

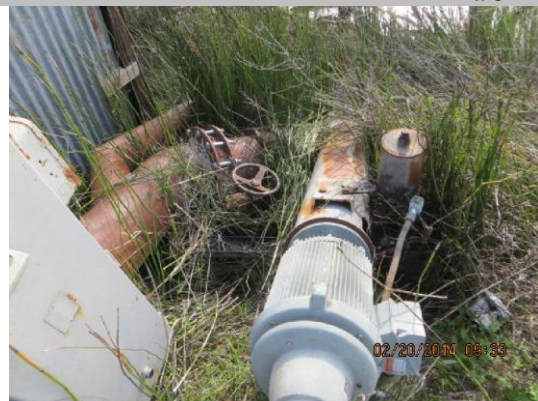
Photo 2 of 3 : UCIP_SP_2018_50187_57438.jpg

Pump, pipe, butterfly valve, and shed visible on WS slope.

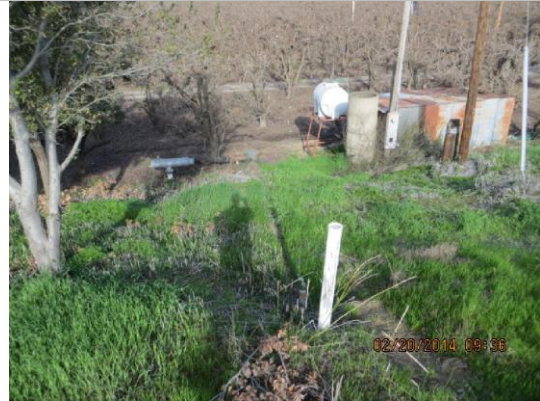
Photo 3 of 3 : UCIP_SP_2018_50187_57437.jpg

FS_ID:50187
DS_ID:22272
EP_NO: N/A
Repair Type: Urgent
Crossing Status: Found
UCIP Comments: 07/06/2016 Highway has been since paved so pot hole not visible. No evidence of repair. (DWR UCIP - kfazel)02/20/2014 Dip in pavement over pipe on North bound lane may indicate internal leak in pipe. Good candidate for video inspection. (DWR UCIP - pamatya)
FIELD_STRUCT_DESC: 16-inch steel irrigation discharge pipe through the levee, invert elevation 6.2 feet below the crown. 12-inch steel pipe sleeved through the existing 16-inch pipe with the annular space grouted. Slant pump on the waterside (WS) slope next to the pump house. Butterfly valve and siphon breaker/vent at the pump on the WS slope. Siphon breaker/vent on the landside (LS) shoulder. Filter, pump, vent, and butterfly valve at the LS toe. The current 16-inch pipe replaced the abandoned 10-inch pipe under DSID 22273. (Plans for plugging up an existing 10-inch steel discharge pipe and installing a new 16-inch steel discharge pipe through the levee authorized under Permit No. 1136, 1946 - Dennis W. Leary. Plans to install a 12-inch irrigation intake pipe inside an existing 16-inch pipe in the levee authorized under Permit No. 14811, 1988 - Leary Ranch, Inc).

Vent/siphon breaker on LS shoulder.

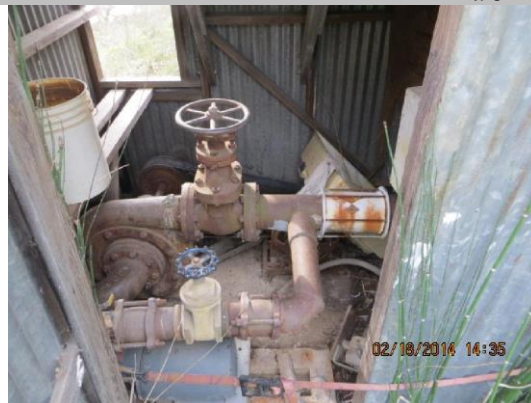
Photo 1 of 3 : UCIP_SP_2018_31349_57435.jpg

| FS_ID:31349 DS_ID:22275 EP_NO: 3738 Repair Type: Non-Urgent Crossing Status: Found UCIP Comments: Heavy foliage over pipe and appurtances on LS slope. FIELD_STRUCT_DESC: 6-inch steel irrigation discharge pipe through the levee, invert elevation 5.5 feet below the crown. Pump and gate valve in a pump house on the waterside (WS) slope. 1.5-inch steel electrical conduit through the levee at the same location. (Plans to insert a new 4-inch pipe through an existing 6-inch irrigation pipe through the levee authorized under Permit No. 3738, 1961 - Emmett James). [Additional Reference(s): DWR Levee Log, 1993. USACE Sacramento O&M Manual 104, February 1960, (RM 24.48)]. FS Date: 2/18/2014 | | | | | | |

Pump, pipe, and gate valves in pumphouse on WS slope.

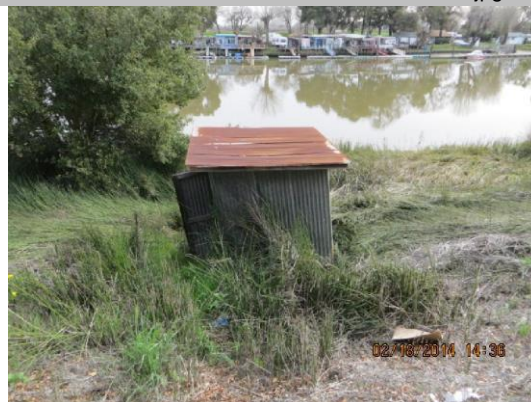
Photo 2 of 3 : UCIP_SP_2018_31349_57434.jpg

Pumphouse on WS slope.

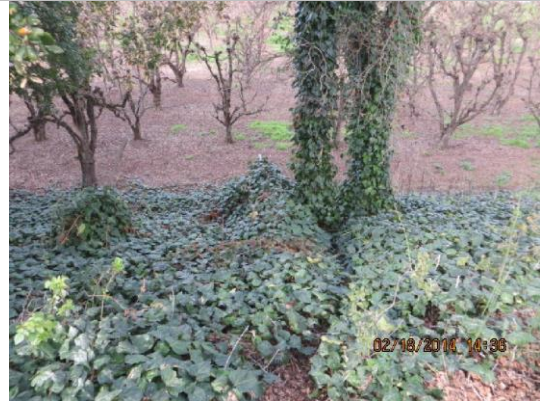
Photo 3 of 3 : UCIP_SP_2018_31349_57433.jpg

| FS_ID:31349 DS_ID:22275 EP_NO: 3738 Repair Type: Non-Urgent Crossing Status: Found UCIP Comments: Heavy foliage over pipe and appurtances on LS slope. FIELD_STRUCT_DESC: 6-inch steel irrigation discharge pipe through the levee, invert elevation 5.5 feet below the crown. Pump and gate valve in a pump house on the waterside (WS) slope. 1.5-inch steel electrical conduit through the levee at the same location. (Plans to insert a new 4-inch pipe through an existing 6-inch irrigation pipe through the levee authorized under Permit No. 3738, 1961 - Emmett James). [Additional Reference(s): DWR Levee Log, 1993. USACE Sacramento O&M Manual 104, February 1960, (RM 24.48)]. FS Date: 2/18/2014 | | | | | | |

Pipe visible at LS toe.

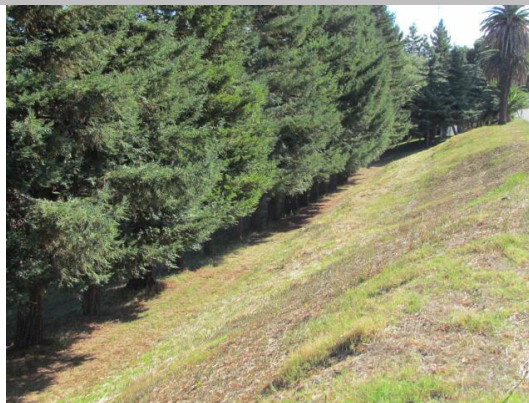
Photo 1 of 2 : SP_2018_RD0003_25_101_20180305_00088.jpg

| Large redwood trees at the landside toe and berm. | | | | | |

Looking northeast at dense redwood trees on landward toe and berm.

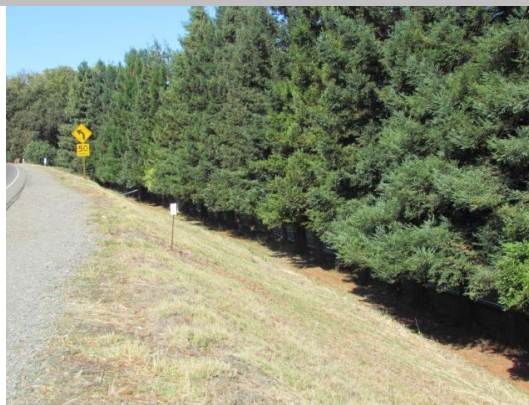
Photo 2 of 2 : SP_2018_RD0003_25_101_20180305_00089.jpg

Looking southwest at dense redwood trees on landward toe and berm.

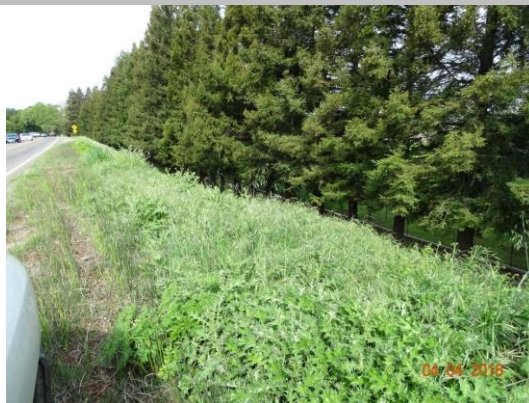
Photo 1 of 1 : SP_2018_RD0003_25_183_20180404_00293.jpg

Heavy vegetation on landside slope prevents inspection.

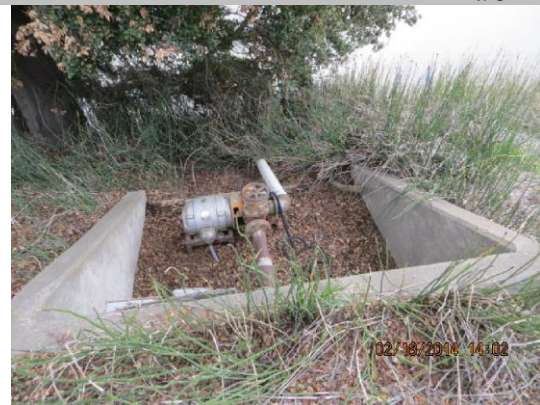
Photo 1 of 3 : UCIP_SP_2018_30408_55931.jpg

Pump and shutoff valve on concrete pad on WS slope.

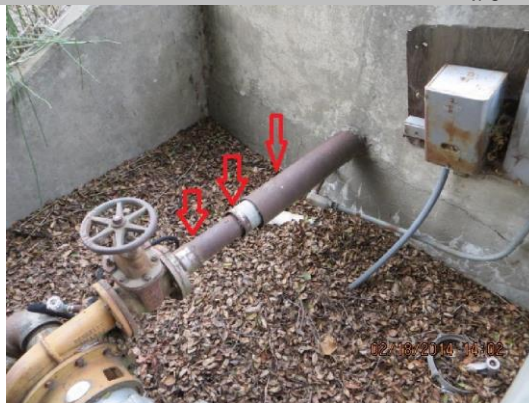
Photo 2 of 3 : UCIP_SP_2018_30408_55930.jpg

2 pipes sleeved through 6-inch pipe.

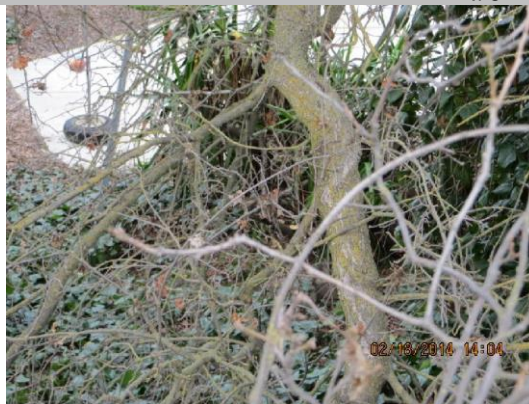
Photo 3 of 3 : UCIP_SP_2018_30408_55929.jpg

Concrete standpipe covered in vegetation on LS toe.

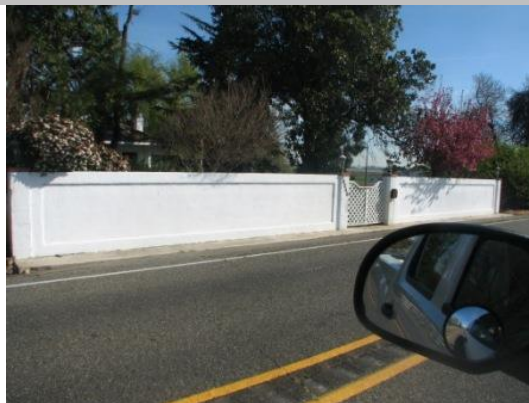
Photo 1 of 1 : SP_2018_RD0003_25_19_20180305_00026.jpg

Block/Concrete fence on landside shoulder at LM 10.13
